Manhole Inspection Summary

Manhole # S27I__034MH

Insp Date: **5/27/08 9:14 AM**

Location Address: **916 W Pratt St**

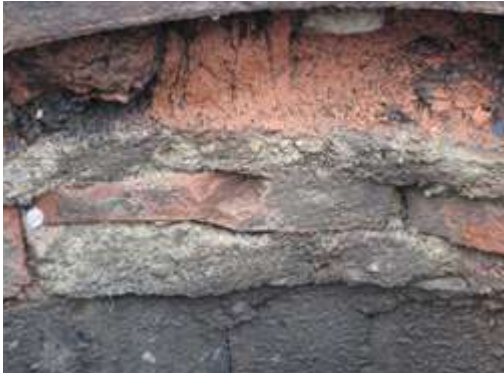
Defect 3

Condition: ☐ Sound ☐ Cracked ☐ Root Intrusion ☐ Loose Brick ☒ **Deteriorated**

Infiltration: ☐ None ☒ **Joint** ☐ Cracks ☒ **Mortar** ☐ Roots ☒ **Wall**

chimney cond deteriorated, joint, mortar, chimney flow wall

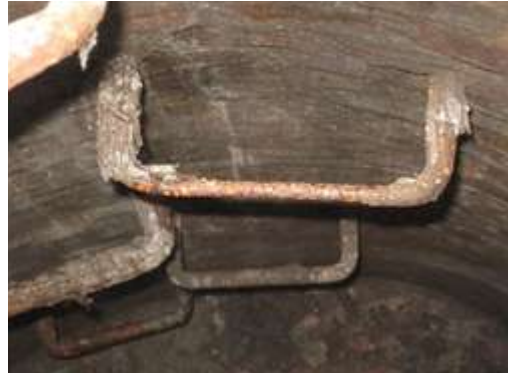
Defect 2

Count: **5** Missing: **0** ☒ **Corroded**

corroded steps

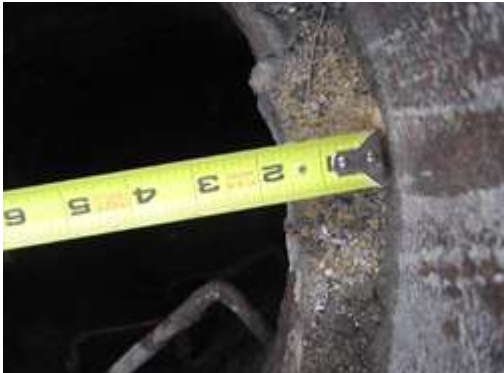
Defect 5

Offset: **1.5** (in.)

Condition: ☐ Sound ☐ Cracked ☒ **Leaks**

Frame offset 1.5

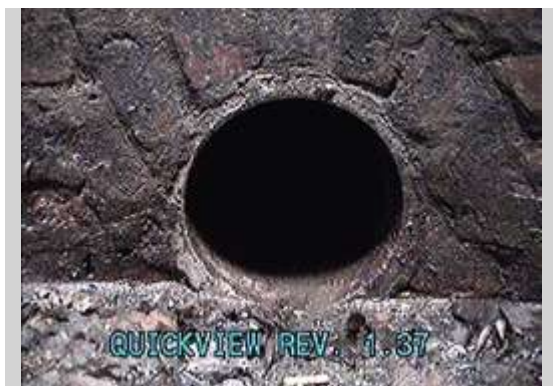
12 O'Clock Outflow

8 in. Circular Gravity Sewer
Pipe Out @ 12 O'Clock

Pipe Height: **8.4** (in.) Rod and Bar (Angled)

Pipe Material: **Clay** ☐ Pipe Lined

Invert Depth: **12.68** (ft.) Flow Characteristics: **None**

Infiltration: **None** Pipe Seal Cond: **Sound**
